Contract #: 04-0120F4Cty: SF/ALA Rte: 80 PM: 13.2/13.9File #: 69.28**WELDING INSPECTION REPORT****Resident Engineer:**Pursell, Gary**Address:** 333 Burma Road**City:** Oakland, CA 94607**Report No:** WIR-002702**Date Inspected:** 29-May-2008**Project Name:** SAS Superstructure**OSM Arrival Time:** 700**Prime Contractor:** American Bridge/Fluor Enterprises, a JV**OSM Departure Time:** 1700**Contractor:** Zhenhua Port Machinery Company, Ltd (ZPMC), Changxing Island **Location:** Shanghai, China**CWI Name:** Sun Wei**CWI Present:** Yes No**Inspected CWI report:** Yes No N/A**Rod Oven in Use:** Yes No N/A**Electrode to specification:** Yes No N/A**Weld Procedures Followed:** Yes No N/A**Qualified Welders:** Yes No N/A**Verified Joint Fit-up:** Yes No N/A**Approved Drawings:** Yes No N/A**Approved WPS:** Yes No N/A**Delayed / Cancelled:** Yes No N/A**Bridge No:** 34-0006**Component:** OBG**Summary of Items Observed:**

WELDING INSPECTION REPORT

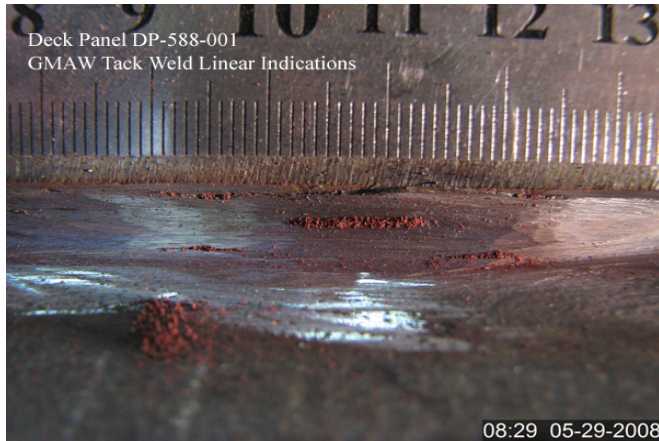
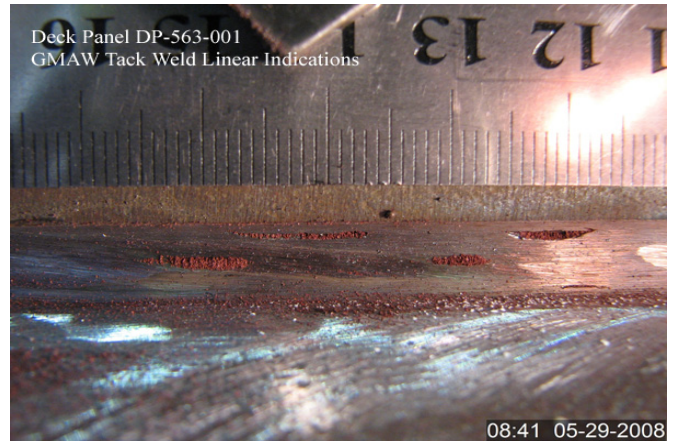
The Quality Assurance Inspector performed magnetic particle inspection to the tack welds on weld 8 of Deck Panel DP-588-001. Weld 1 contains 21 tack welds. Of the 21 tack welds, 9 appeared to contain linear indications indicative of cracks. In addition, The Quality Assurance Inspector performed magnetic particle inspection to the tack welds on weld 1 of Deck Panel DP-563-001. Weld 1 contains 21 tack welds. Of the 21 tack welds, 14 appeared to contain linear indications indicative of cracks. ABF representative Warren Buehler was notified by the Quality Assurance Inspector. Mr. Buehler stated that ABF has recommended that all the tack welds be magnetic particle tested. At completion of the Quality Assurance Inspectors shift ZPMC had begun repairing the indications by grinding and retesting by the magnetic particle testing method. Below are two digital photographs of cracked GMAW tack welds located by the magnetic particle testing method.

The Quality Assurance Inspector witnessed ZPMC repair the indications by grinding and retesting by the magnetic particle method. ZPMC is only repairing the indications that the Quality Assurance Inspector is observing.
